Pierce Enforcer 100' Midmount Tower  
Flemington Borough  
Job #39962

FEATURES & SPECIFICATIONS

<b>MANUFACTURING INC.</b>	
100' ASCENDANT AERIAL TONER AND BODY ASSEMBLY	
BOROUGH OF FLEMINGTON	
FLEMINGTON, NJ	
39962AD

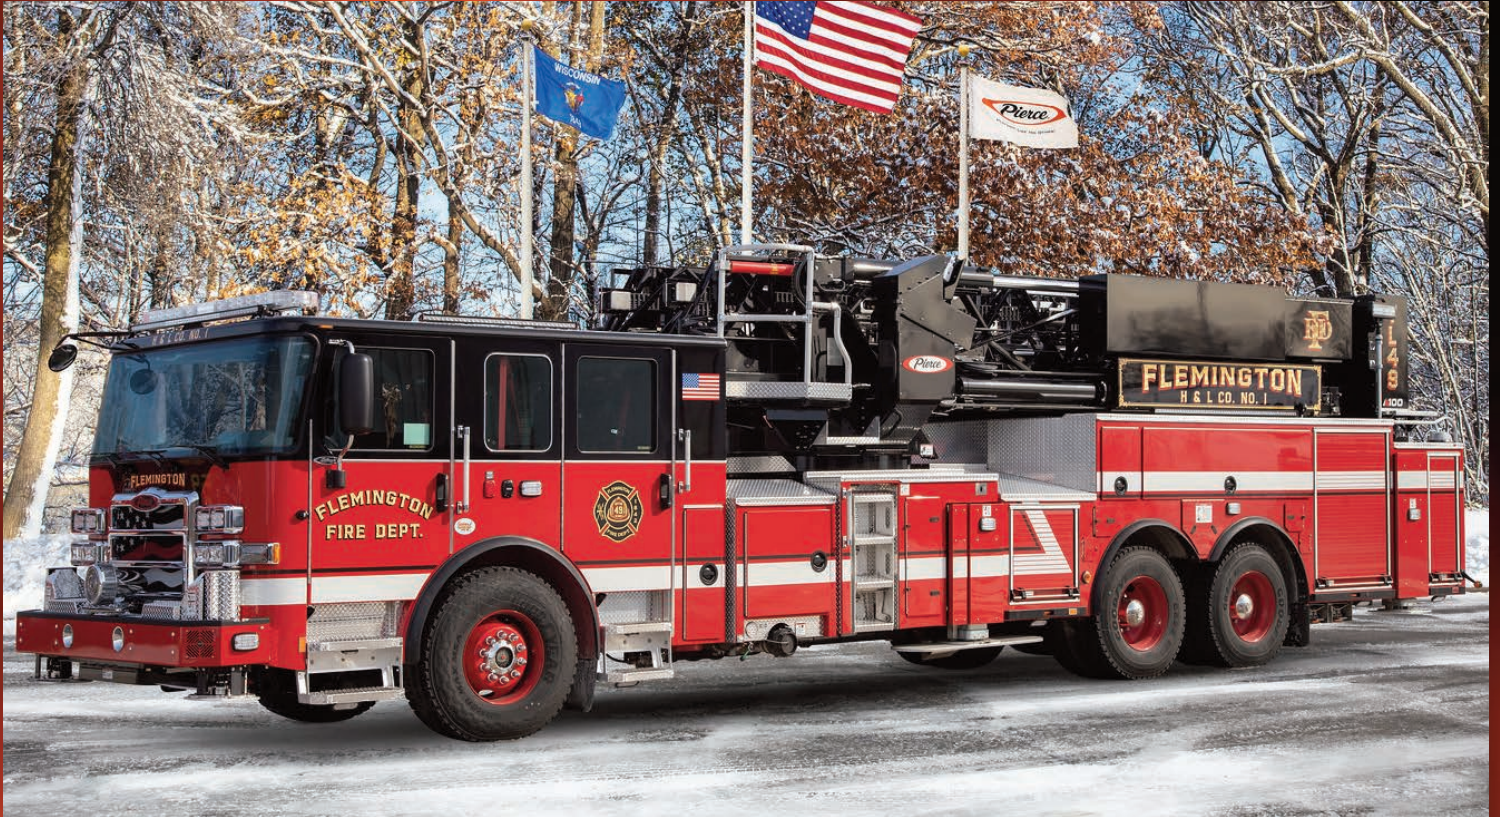
- Pierce Enforcer 70" Chassis with a Flat Roof
- Cummins X12 500hp 2024 EPA compliant Engine
- Allison EVS4000P Automatic Transmission
- Dana Front and Meritor Rear Axles
- No Tank/No Pump
- Xantrex Freedom X1000 .75kw Inverter
- Delivered in March 2025

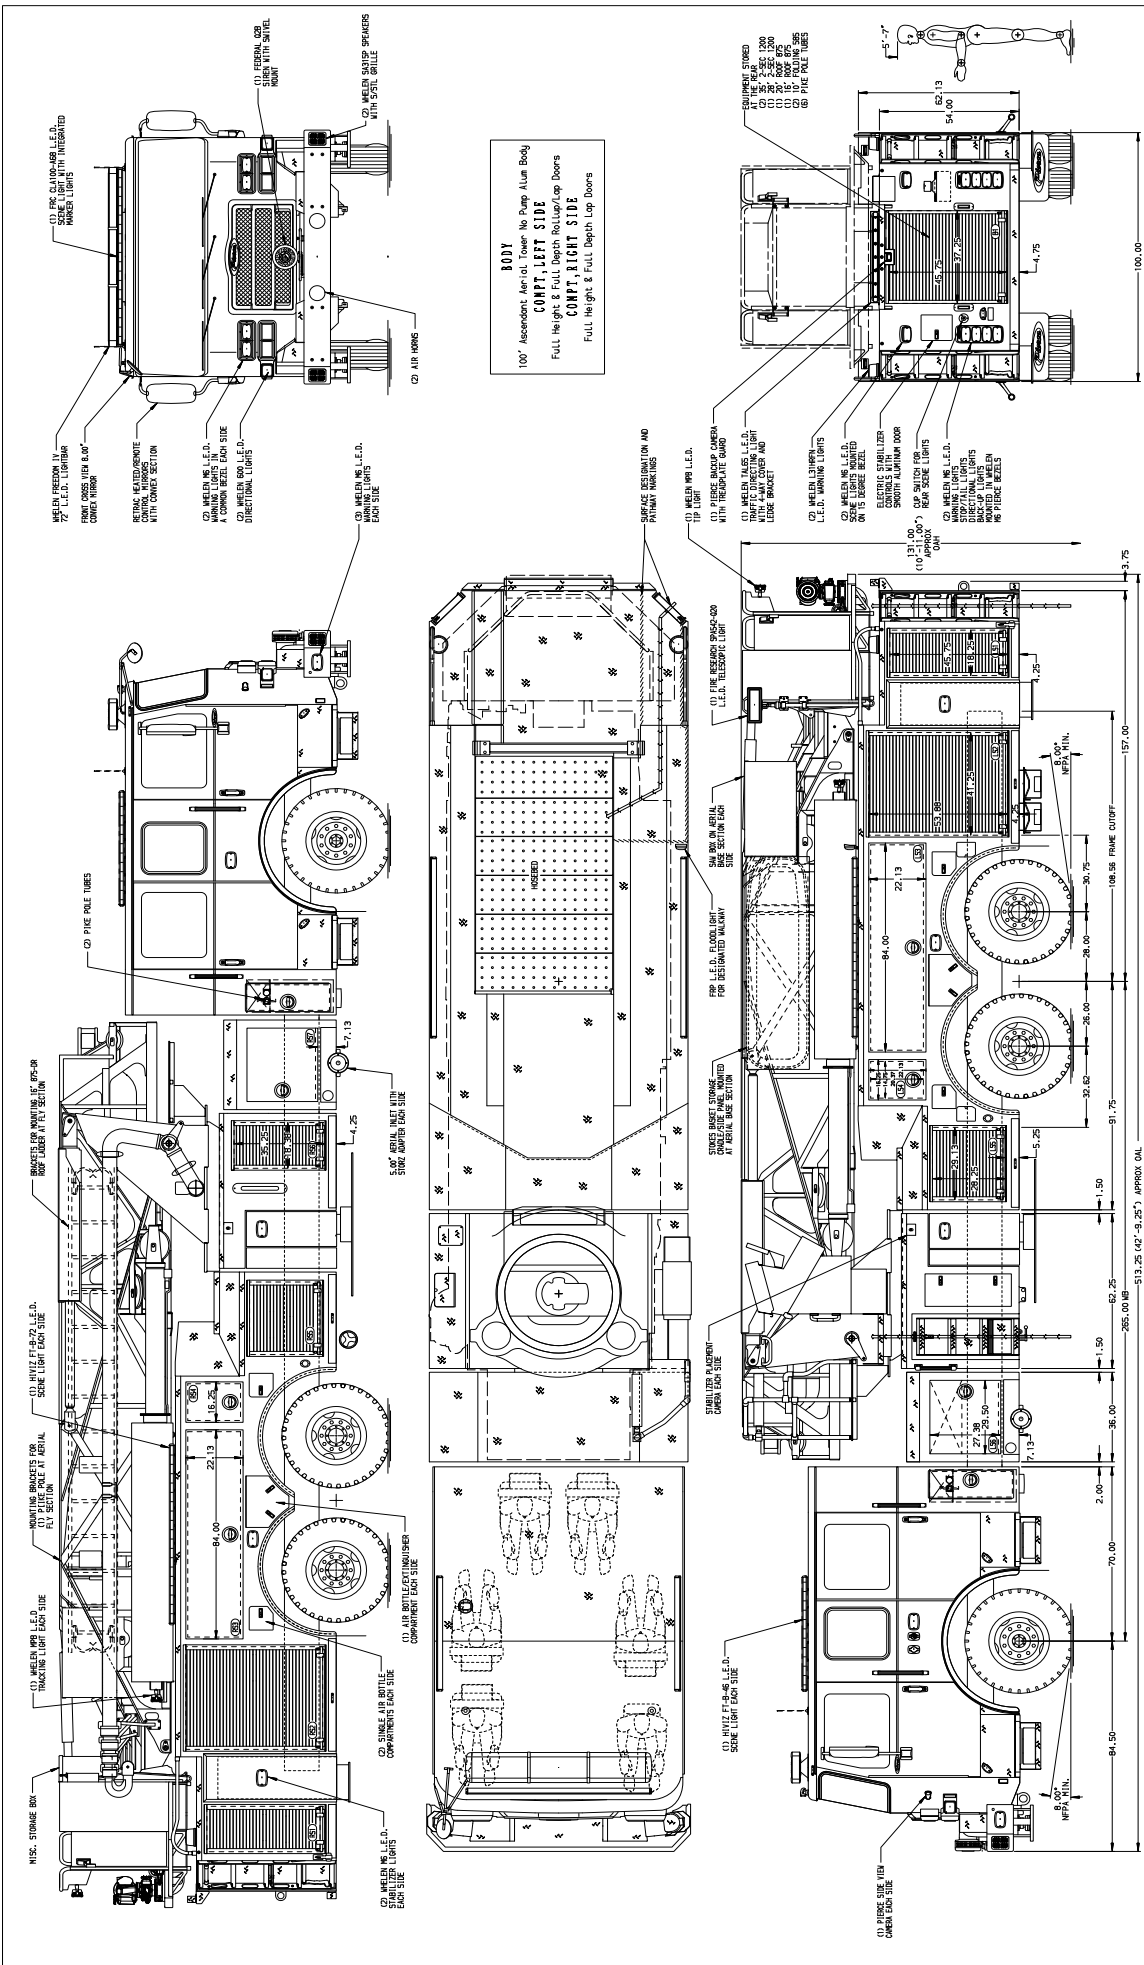
**BODY**  
 100' Ascendant Aerial Toner No Pump Alum Body  
**COMPT. LEFT SIDE**  
 Full Height & Full Depth Roll-over Protection Doors  
**COMPT. RIGHT SIDE**  
 Full Height & Full Depth Roll-over Protection Doors
